GROUTING EFFICIENCY IN VERTICAL SHAFTS

FINAL REPORT

Contract J0156004
Engineers International, Inc.

BUREAU OF MINES

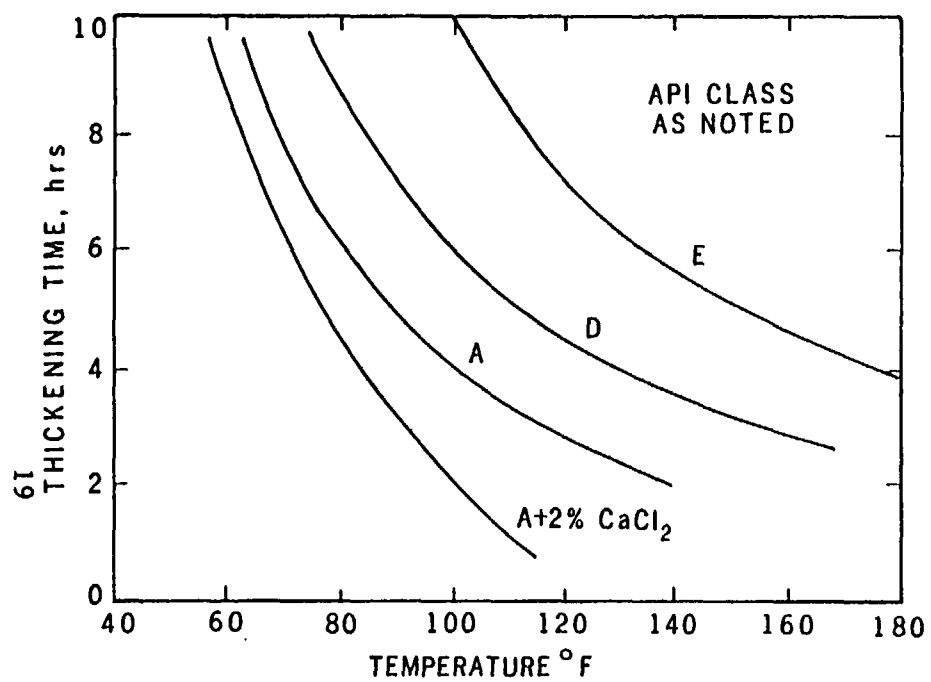
Figure 2. Effect of Temperature and Pressure on Cement Thickening Time
(after Suman and Ellis, 1977)

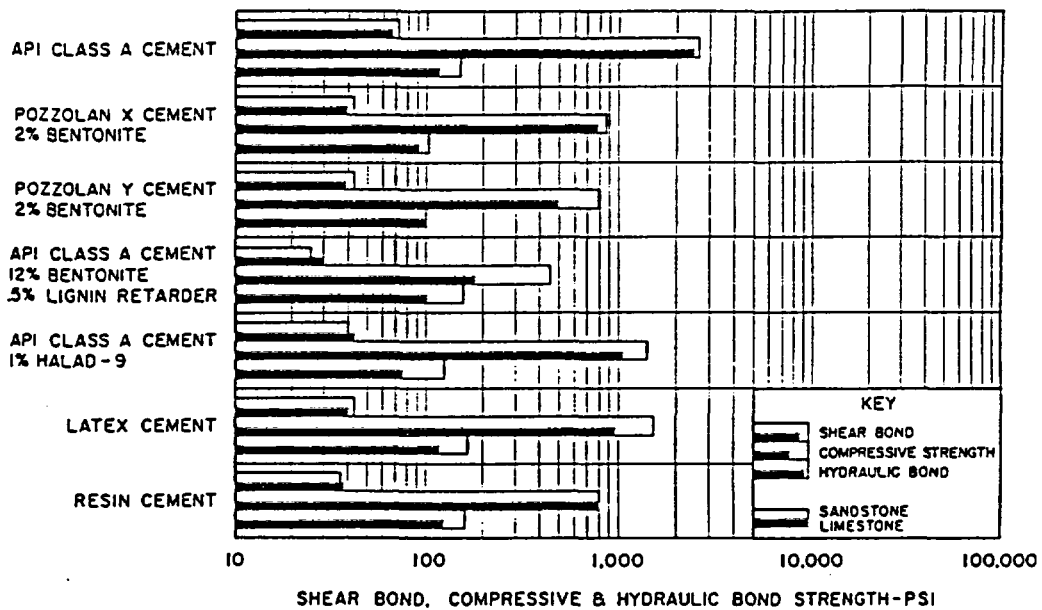
BONDING PROPERTIES OF CEMENT TO FORMATION
CEMENT NOT SQUEEZED-WALLS NOT CLEANED

Figure 4. Effect of Additives on Cement-Formation Hydraulic Bonding (lab tests) (from Evans and Carter, 1962)

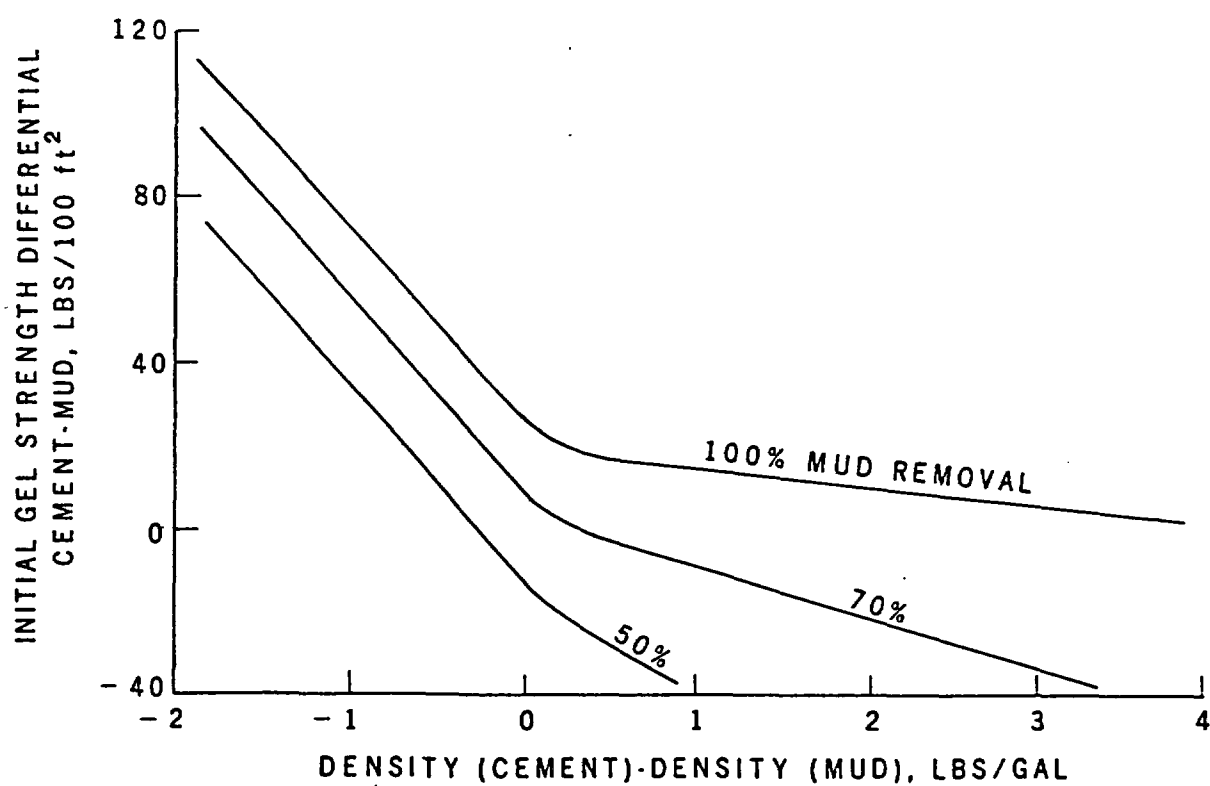
Figure 17. Mud Displacement in Plug Flow
(after Sauvageau, 1984)

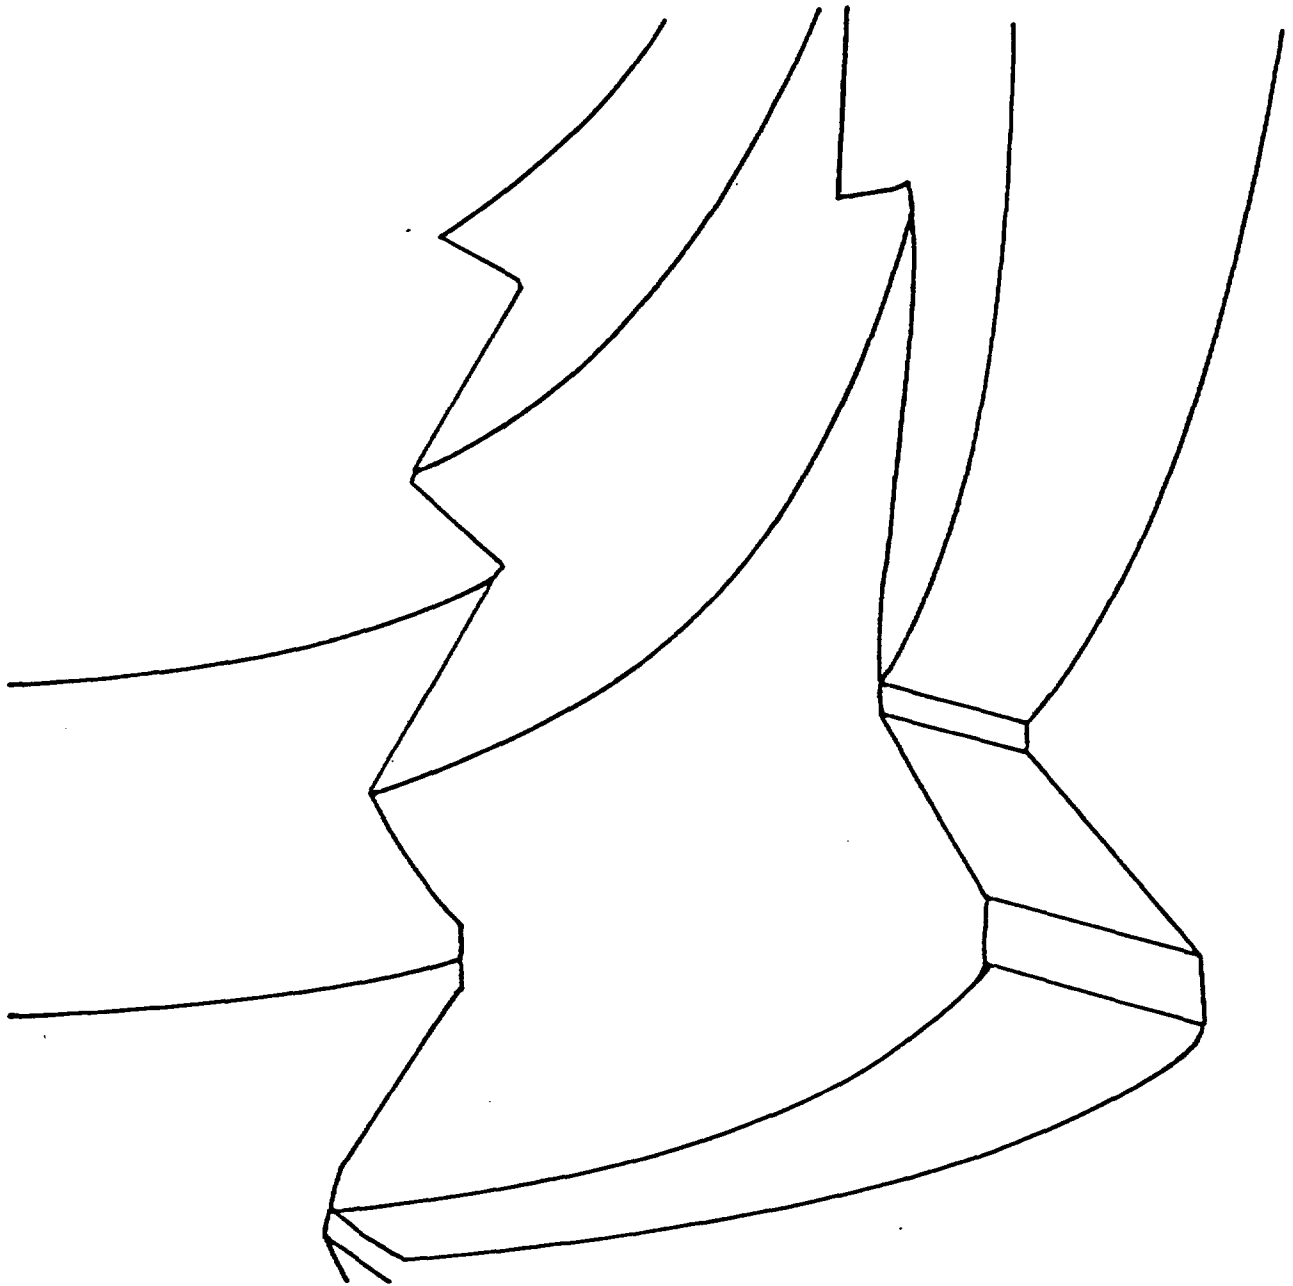
Figure 19. Self Locking Concrete Blocks
